INDOOR AIR QUALITY ASSESSMENT

**District Court of East Norfolk County
(Quincy District Court)
1 Dennis Ryan Parkway
Quincy, Massachusetts**

Prepared by:
Massachusetts Department of Public Health
Bureau of Environmental Health Assessment
April, 2002

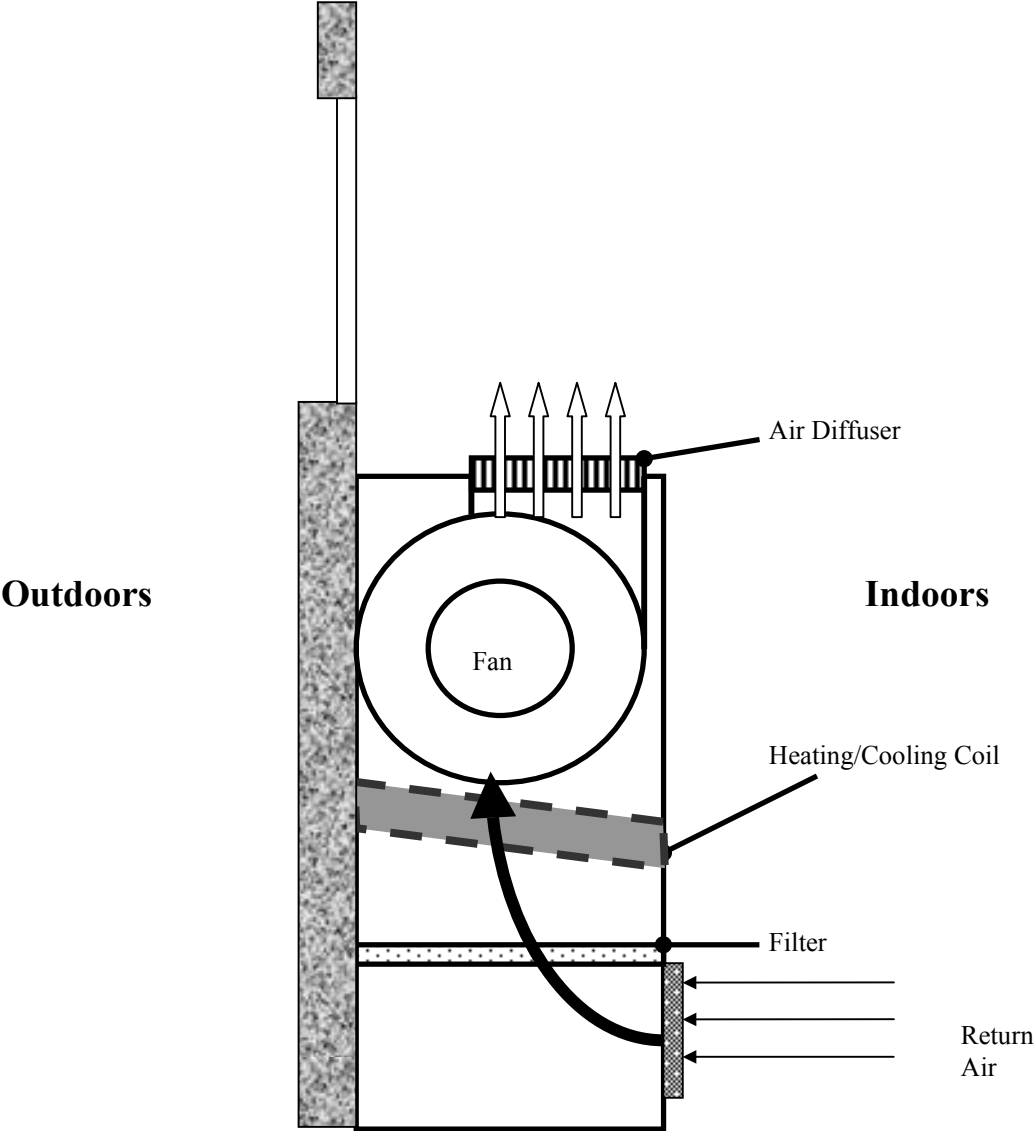
Figure 1

Offices in a number of areas are equipped with a fan coil unit (FCU) (see Figure 1). FCUs are located on exterior walls underneath windows. The purpose of the FCU is to provide heating or cooling by circulating air. FCUs do not introduce fresh outdoor air, but rather draw air from the room through a filter in the base of the cabinet into fans. Fans force air through coils that heat or chill the air. Conditioned air exits the FCU through fixed louvers on the top of the cabinet. FCUs were not operating in most offices evaluated.

Fan Coil Unit (FCU)

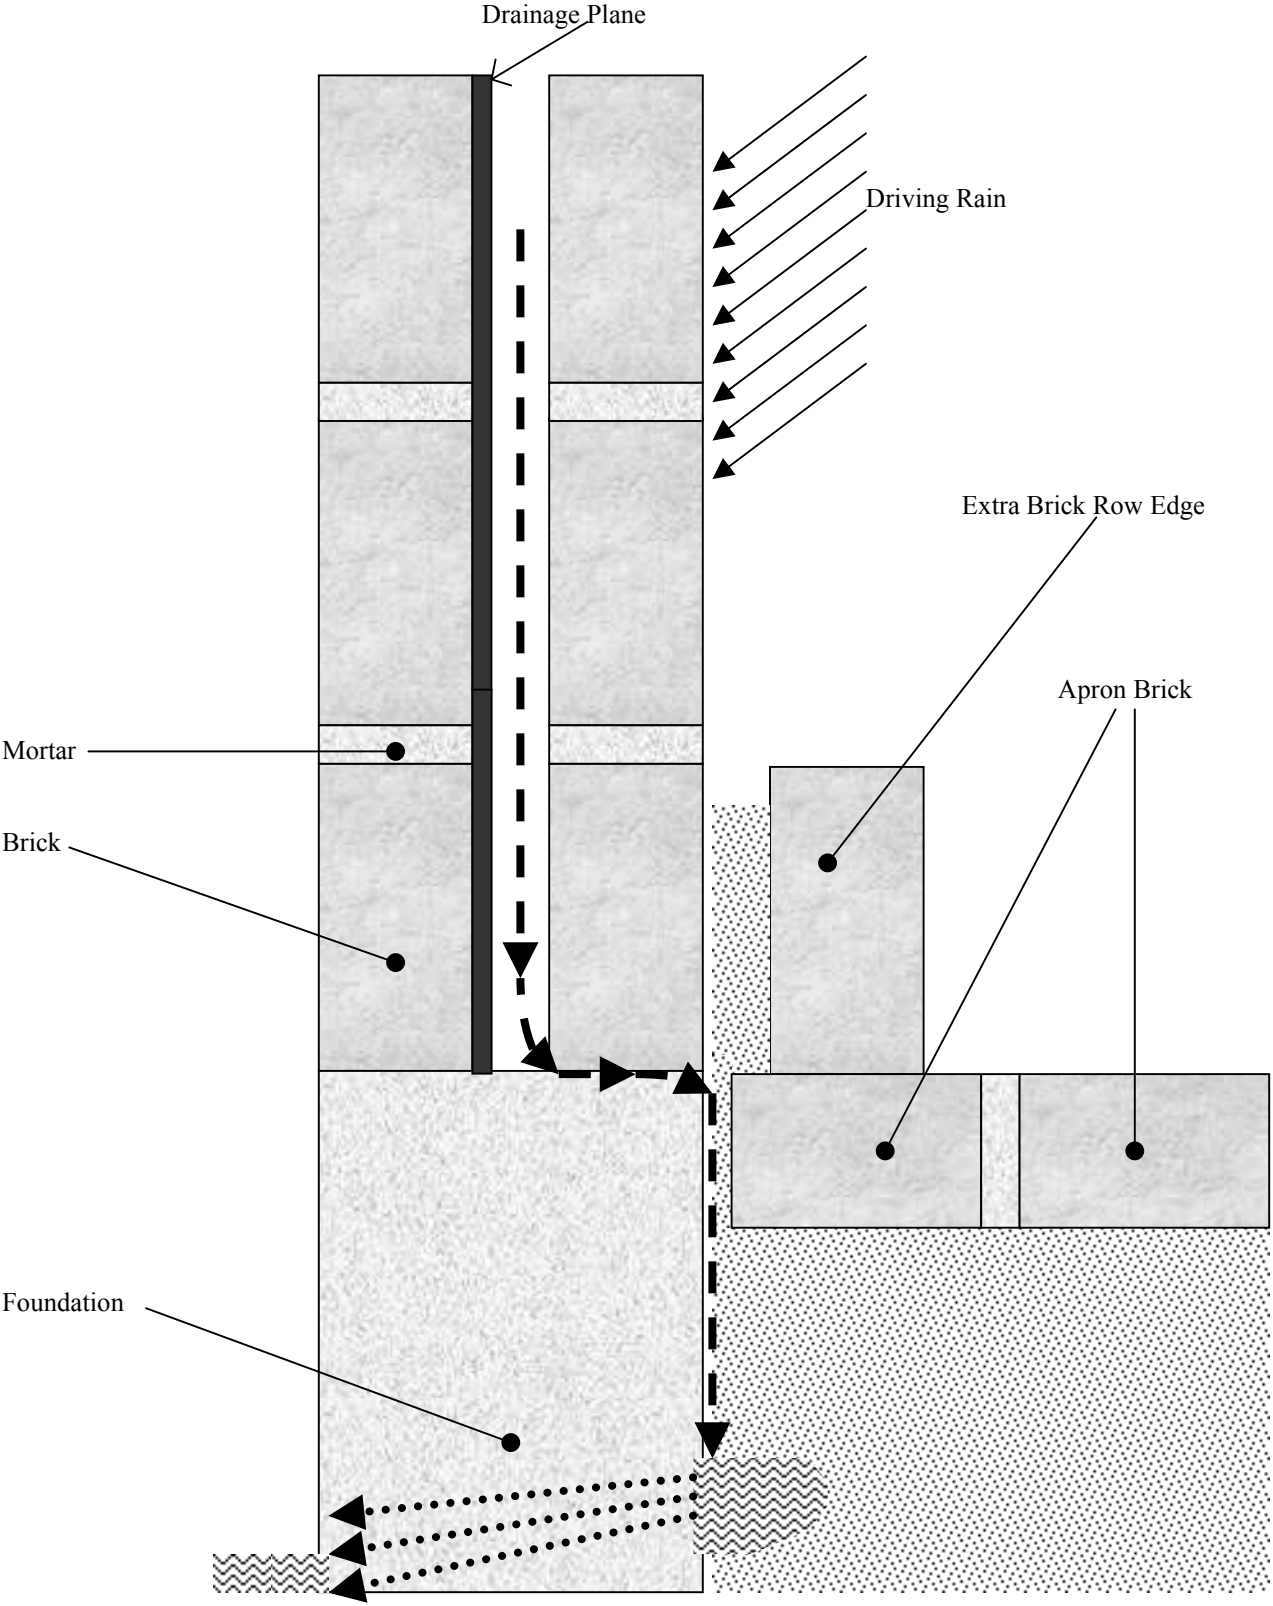
The juvenile probation office in the basement has a chronic water penetration problem through the foundation wall. This problem appears to be related to the combination of the design of the exterior wall and the existence of a line of bricks along the brick apron that surrounds the edge of the building. The basement of the building is at a level that is a minimum of 10 feet below street level. This building configuration required that drains be installed along the perimeter of the building to intercept groundwater rolling down the embankment from the street and parking lot to prevent flooding of the basement during rainstorms. This drainage system is installed within a brick apron installed along the edge of the building (see Picture 5). Rainwater striking the exterior of the building would roll down the exterior brick curtain wall and be drained away by the same system. Along the base of the wall is a line of brick (see Picture 6), which may serve as a berm to block groundwater contact with the foundation wall. Over time, rainwater has contacted the junction between the exterior wall and this line of brick, resulting in the breaking of the mortar seal. This space now allows for water runoff from the exterior curtain wall to pass into the space between bricks and pour water against the foundation wall. Plants have colonized this seam (see Picture 7), which widens the space, increasing the breach to allow for more water contact with the foundation wall. Water has worn through seams in the foundation and primarily migrates into the basement in the juvenile probate court. Significant signs of rainwater penetration exist at the foundation floor junction in this office, including silt (see Picture 8), water damaged carpet and ant infestation (see Picture 9). The American Conference of Governmental

Figure 2
Movement of water into the foundation from drainage plane and exterior wall

1. Runoff rainwater from the exterior wall must be prevented from entering the brick junction shown in Figure 2. The most efficient method to prevent rainwater penetration would be to remove all plants from this seam and install a flashing system over the brick to direct rainwater onto the building apron (see Figure 3). Consider consulting a building engineer to examine this or other feasible options to prevent water penetration. Once rainwater penetration is remediated, repair the foundation wall in the juvenile probation office and remove ant infestation.
2. Water-damaged ceiling tiles should be replaced. These ceiling tiles can be a source of microbial growth and should be removed. Source(s) of water leaks (e.g., window

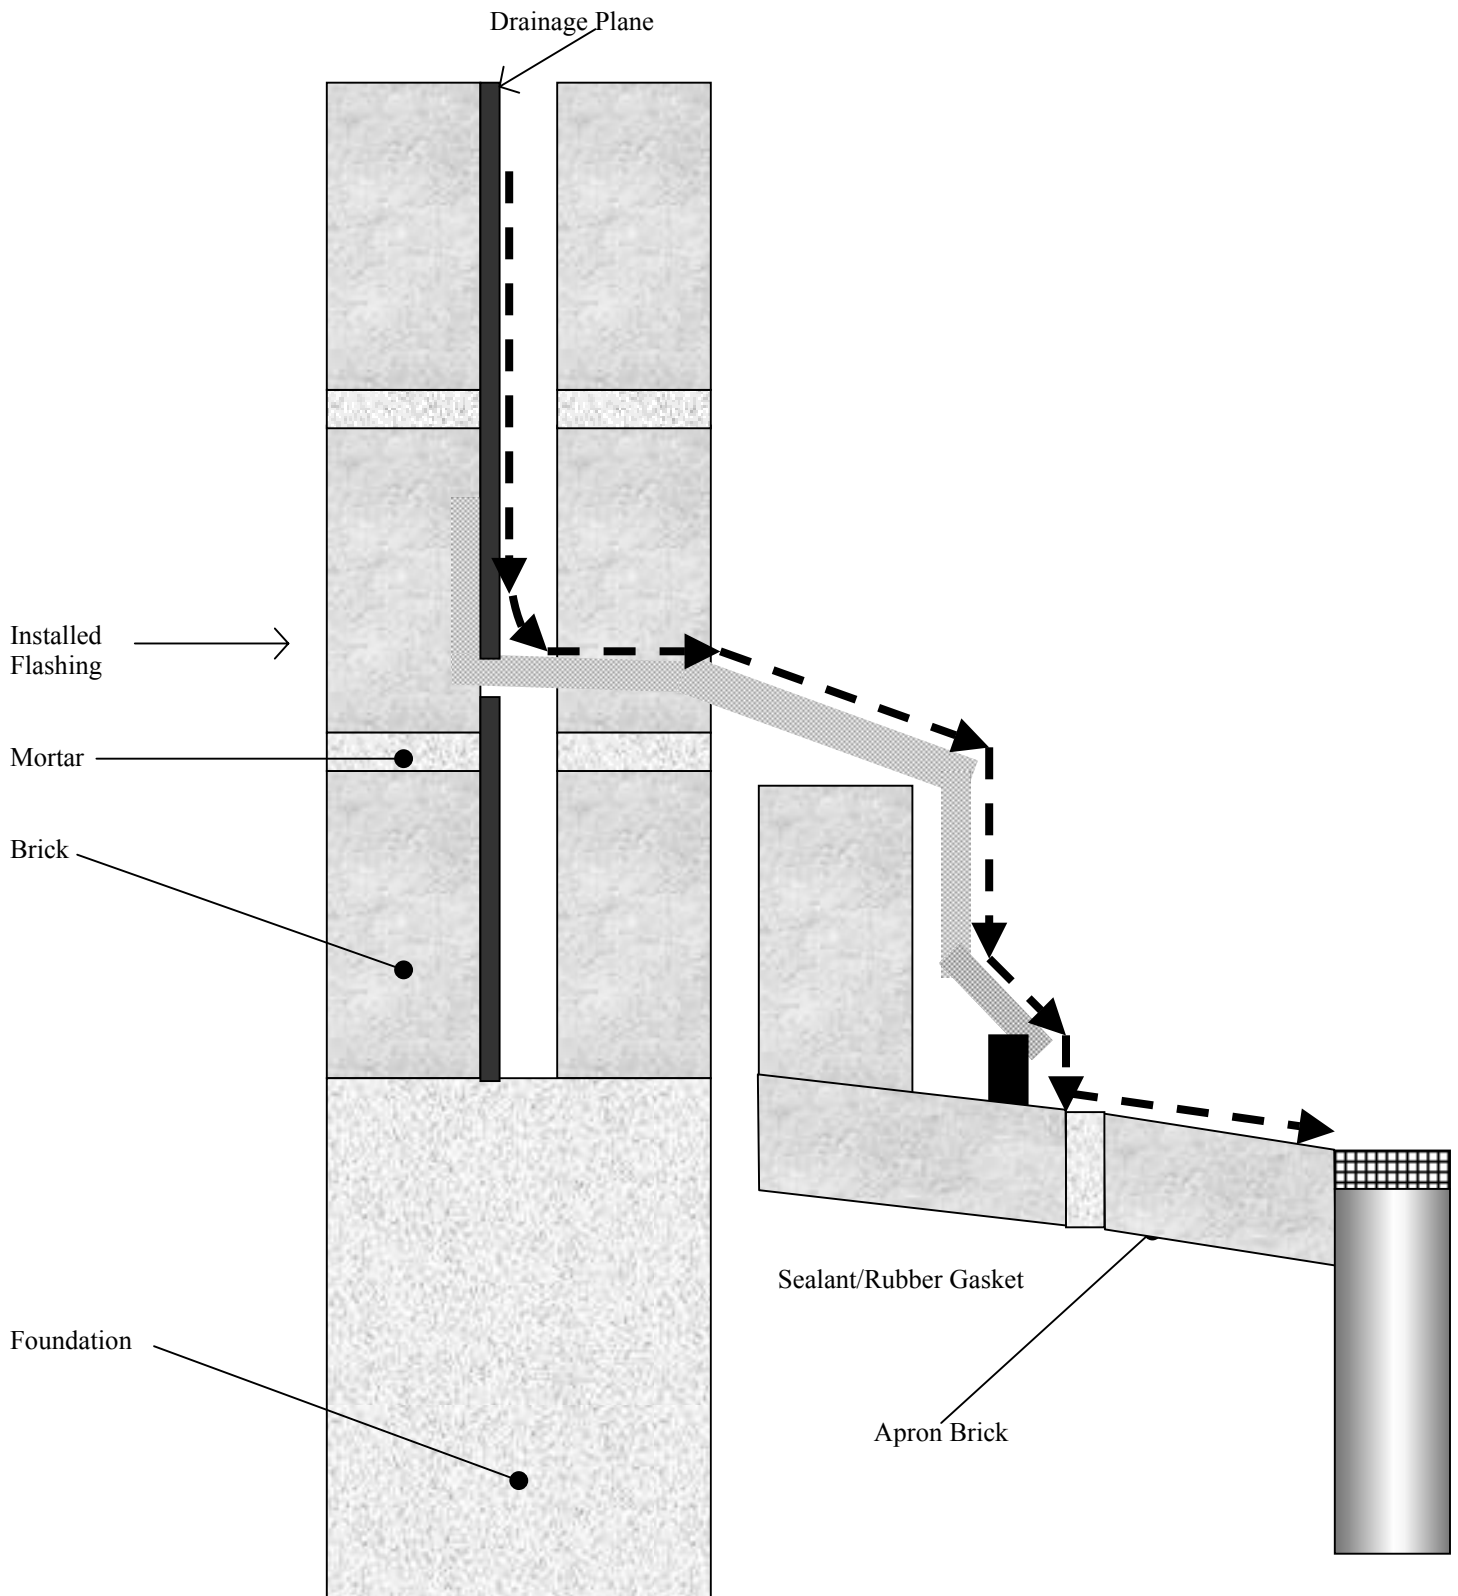
Figure 3
Installation of Flashing to Remove Water from Drainage Cavity

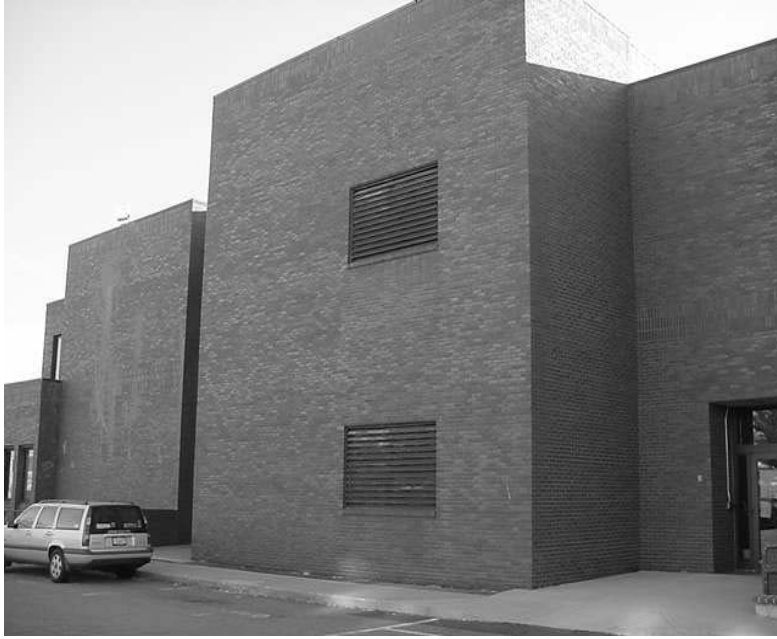
Picture 1

AHU Fresh Air Intakes

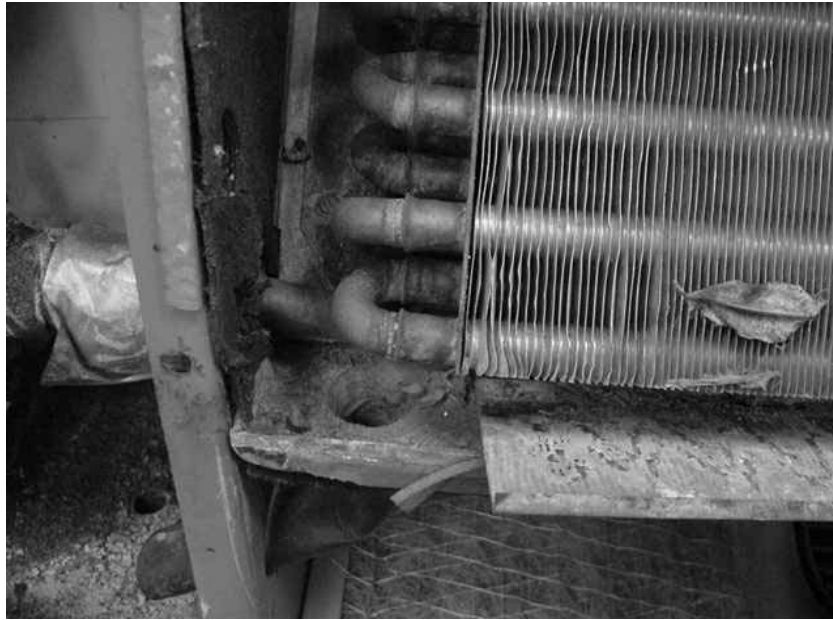
Picture 2

A number of sources of mold colonization exist in areas within the building. As previously mentioned, fan coil units provide both heating and air-conditioning. Each FCU has drip pans to collect and drain condensation from cooling coils. The manufacturer of the FCUs installed a plastic liner to protect the drip pans from water damage (see Picture 2). Several units were examined and were found coated with dirt and other debris, which can serve as growth mediums for mold when these units are activated for air conditioning. Several employees indicated that mold odor emanates from the FCUs when activated. The drip pan collectors (see Picture 3) are also coated with dirt and debris, suggesting that these units are not routinely cleaned.

Caked Debris on Drain Pan Liner. Note Duct Tape

1. Contact the manufacturer to identify the proper procedure to disinfect FCU drain pans. Examine whether plastic liners can be replaced to prevent microbial growth.
2. Clean the interior of FCUs.
3. Once cleaned and operational, operate FCUs during business hours to enhance exhaust of air from private offices.
4. Remove water damaged materials from the juvenile probation office, including carpeting.
5. With a reduction of relative humidity, scrupulous cleaning practices should be adopted to minimize common indoor air contaminants whose irritant effects can

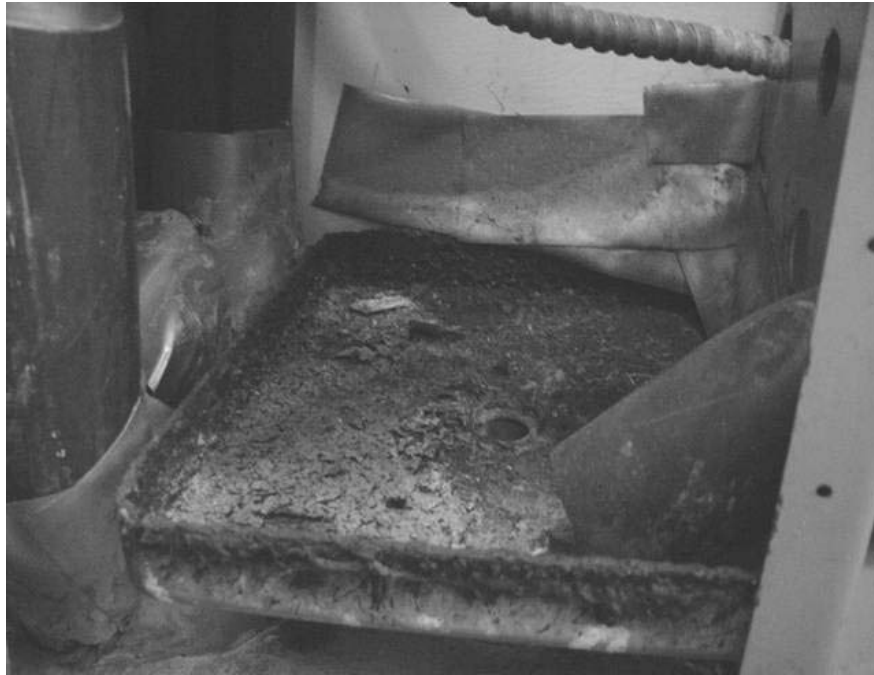
Picture 3

Drip Pan Collector Coated With Debris

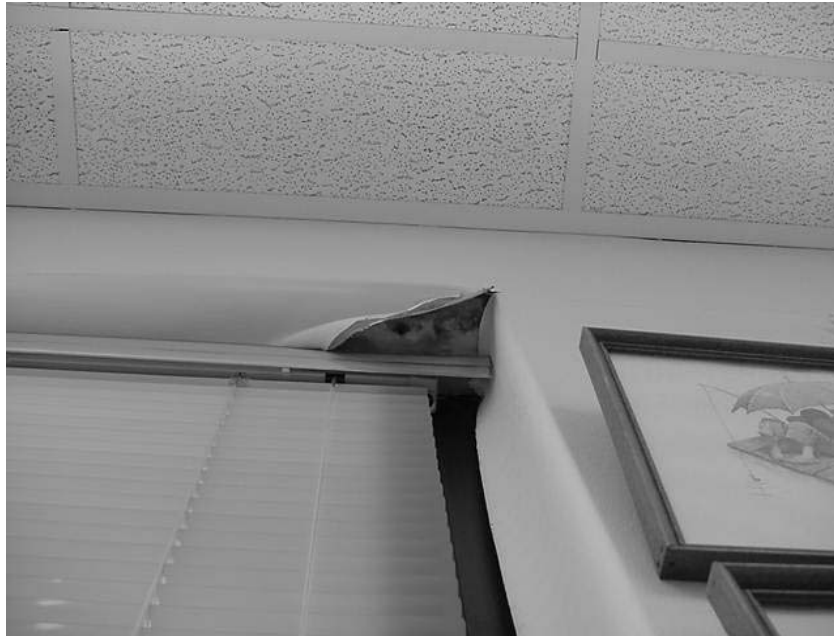
Picture 4

Several notable conditions concerning window frame water leakage were also observed (see Picture 4). Efflorescence was noted, which can indicate chronic exposure to rainwater penetrating through window frames or exterior wall cladding. Efflorescence is a characteristic sign of water damage to brick and mortar, but it is not mold growth. As moisture penetrates and works its way through mortar around brick, water-soluble compounds in bricks and mortar dissolve, creating a solution. As the solution moves to the surface of the brick or mortar, the water evaporates, leaving behind white, powdery mineral deposits. Over time, this condition can result in the breakdown of brick and mortar. Water penetration in this manner can create microbial growth problems if it chronically moistens porous materials. In the case of the QDC, efflorescence was noted in offices with vinyl wallpaper around window frames. Vinyl wallpaper is a water impermeable covering that will prevent water evaporation. Wallpaper paste can serve as a mold growth medium if chronically wet, particularly if covered with vinyl wallpaper. Areas with efflorescence were free of mold-related odors and visible mold growth, which

would indicate that water affected the edges of vinyl wallpaper sheets, which dried after losing adherence to the water damaged walls. If visible mold growth or related odors manifest in the future, removal of the vinyl wallpaper would be advisable.

Window Frame Water Leakage, Note Peeled Vinyl Wallpaper

3. Consideration should be given to installing/extending exhaust ventilation to all occupied areas in the basement.
4. Consider replacing vinyl wallpaper around windows with an alternative covering that is water permeable. Repair water damaged plaster once window leaks are remediated.

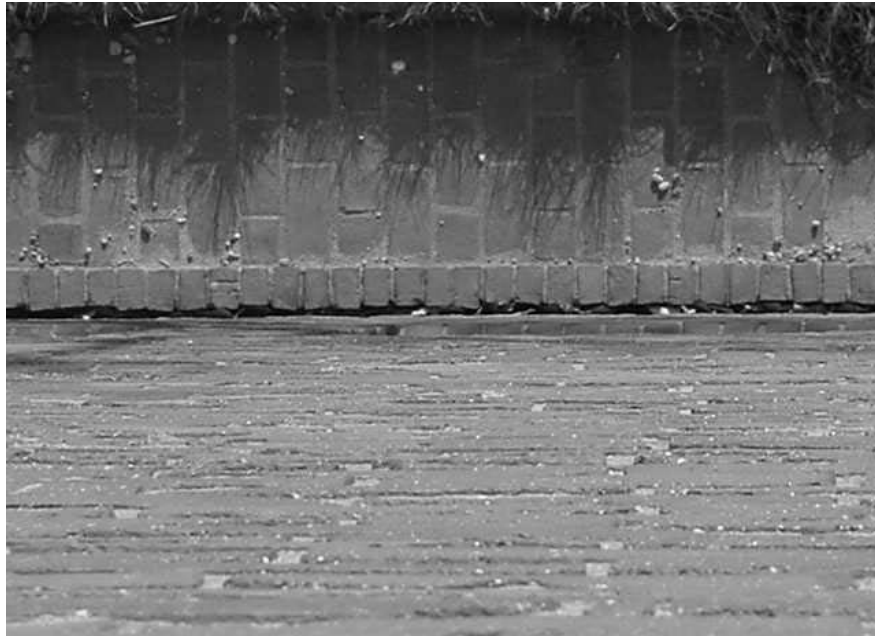
Picture 5

Brick Apron Around the Edge of the Building, Note Seam between Bricks

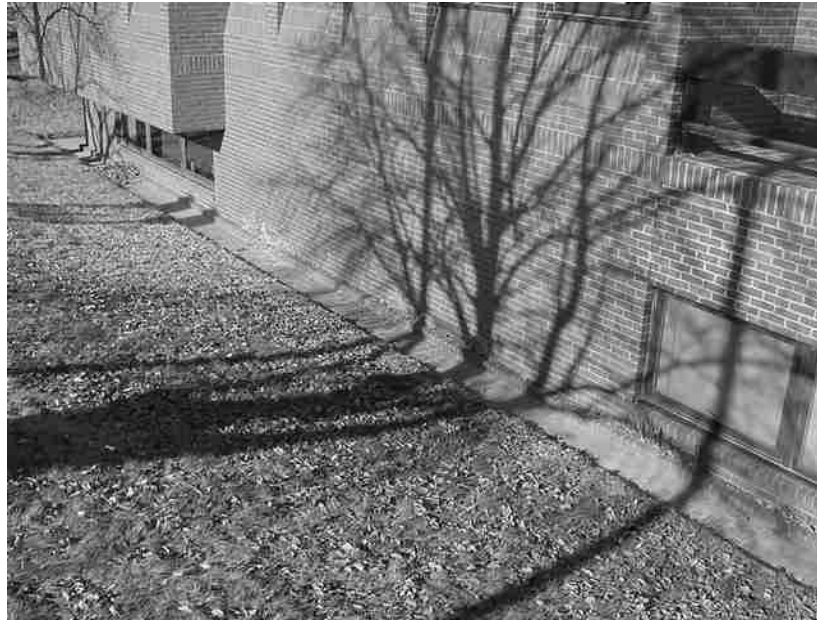
Picture 6

Line Of Brick Along Base Of Exterior Wall Outside Juvenile Probation Office, Note Lack Of Window Or Overhang That Would Impede Rainwater Runoff

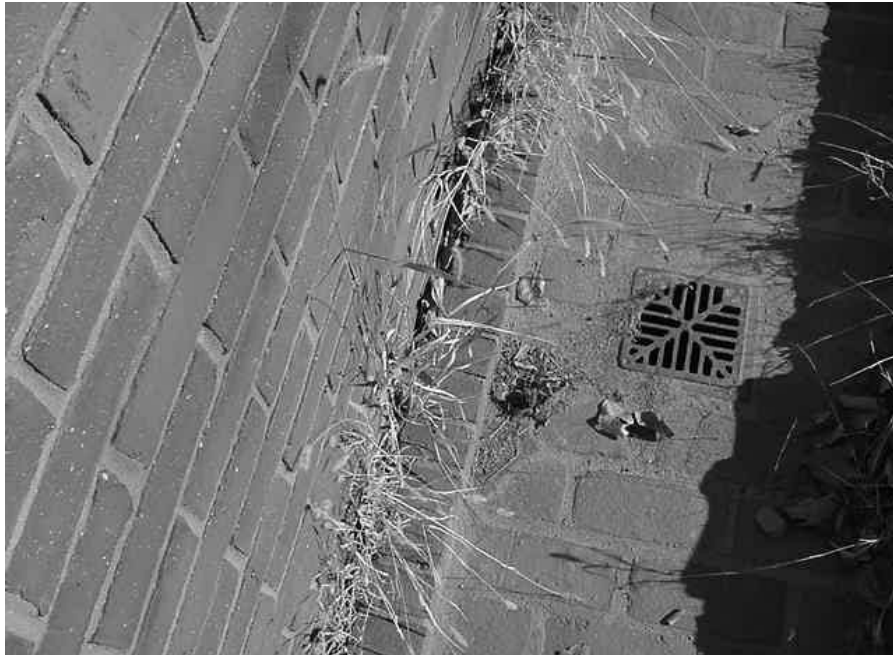
Picture 7

Plants In Seam at Base of Building

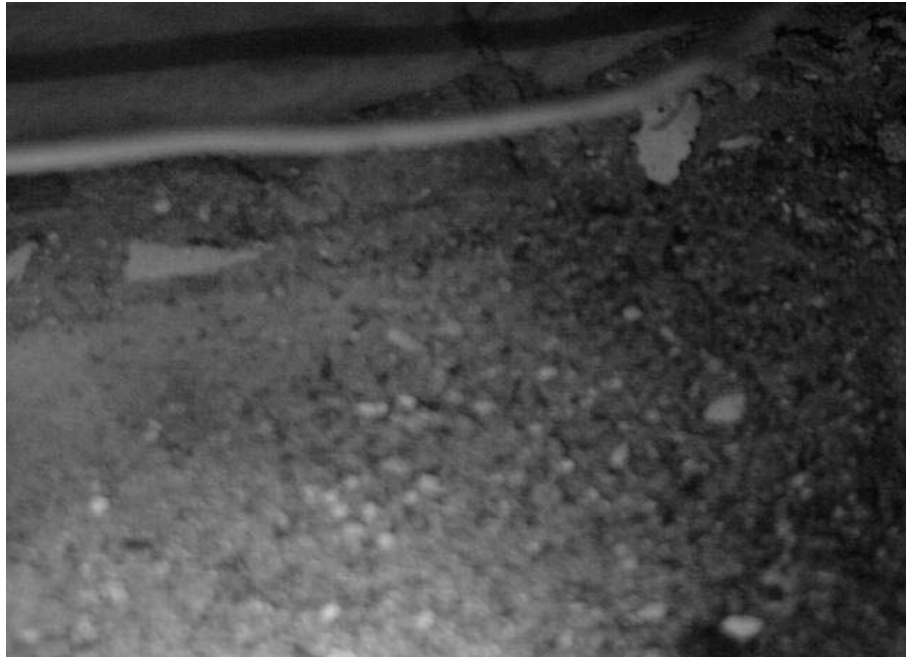
Picture 8

Accumulated Silt in the Juvenile Probation Office

Industrial Hygienists (ACGIH) recommends that porous materials such as carpet, cardboard and other porous materials be dried with fans and heating within 24 hours of becoming wet (ACGIH, 1989). If porous materials are not dried within this time frame, mold growth may occur. Water-damaged porous materials cannot be adequately cleaned to remove mold growth. The application of a mildewcide to moldy porous materials is not recommended. Fungal microbial growth begins once water soaks porous materials. The fungus grows through its lifecycle, which produces spores. Dependent on the species of fungi, some spores are extremely buoyant and can be drawn into the interior of the room by operation of the ventilation system. In order to prevent further water penetration, measures to eliminate rainwater runoff along the exterior curtain wall above the juvenile probation office need to be implemented.

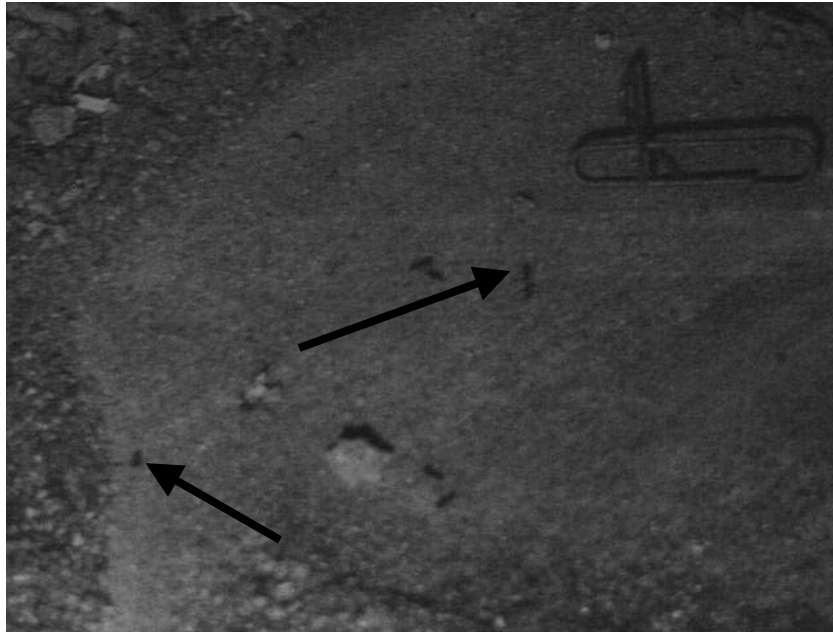
Picture 9

Ants under Carpet in Silt in Juvenile Probation Office

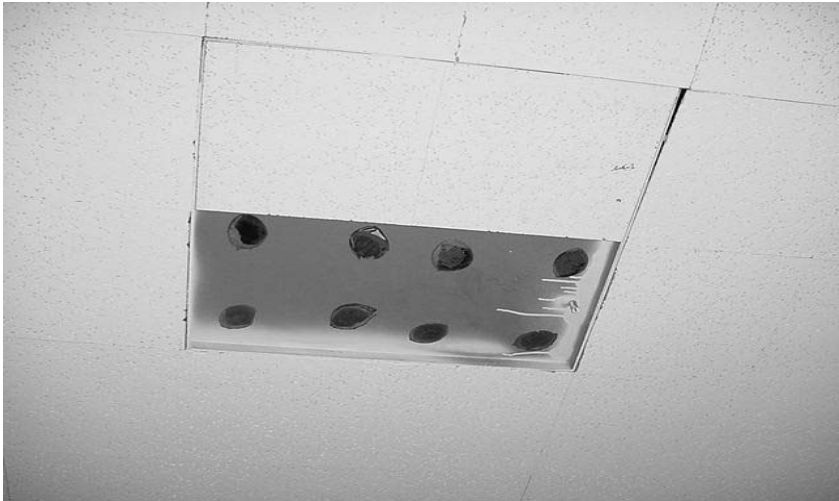
Picture 10

The QDC has a ceiling tile system that is glued directly to the ceiling in a number of areas (see Picture 10). Several hallways and offices have ceiling tiles that appear to be water-damaged by old roof leaks. Replacement of these ceiling tiles is difficult, since their removal appears to necessitate the destruction of the tile, which can result in the aerosolization of particulates.

Glued On Ceiling Tile

frames and roof) should be identified and repaired. Examine the non-porous surface beneath the removed ceiling tiles and disinfect with an appropriate antimicrobial.

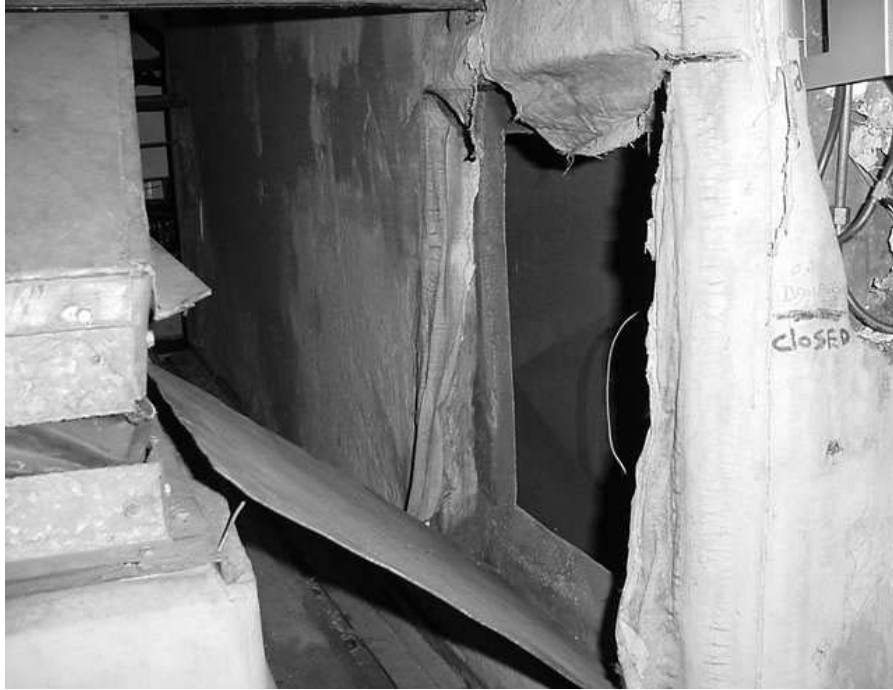
Picture 11

An examination of the AHU in the mechanical room found an ajar panel in the ductwork (see Picture 11). Ajar panels can result in mechanical room particulate and odors being entrained into this duct and distributed by the AHU to occupied areas.

Ajar HVAC Duct Panel In Mechanical Room

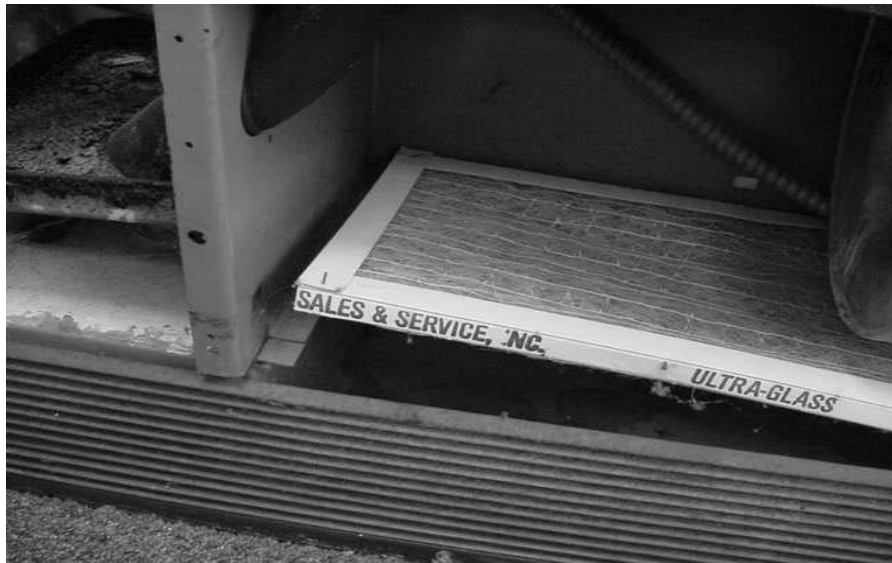
Picture 12

Each FCU is also outfitted with a filter. Filters were either undersized or did not fit properly into racks (see Picture 12), which can result in unfiltered return air to be redistributed into the office during FCU operation. This results in dust, dirt and other debris being distributed by the ventilation system. FCUs and AHUs are equipped with filters that strain particulates from airflow. In order to decrease aerosolized particulates, disposable filters with an increased dust spot efficiency can be installed. The dust spot efficiency is the ability of a filter to remove particulates of a certain diameter from air passing through the filter. Filters that have been determined by ASHRAE to meet its standard for a dust spot efficiency of a minimum of 40 percent would be sufficient to reduce airborne particulates (Thornburg, D., 2000; MEHRC, 1997; ASHRAE, 1992). Note that increased filtration can reduce airflow produced by the unit by increased resistance (called pressure drop). Prior to any increase of filtration, each FCU should be evaluated by a ventilation engineer to ascertain whether they can maintain function with more efficient filters.

Ajar Filter in FCU

- be enhanced when relative humidity is low. An increase in filter efficiency in the HVAC system may also be advisable. Drinking water during the day can help ease some symptoms associated with a dry environment (throat and sinus irritations).
6. In order to decrease aerosolized particulates, disposable filters with an increased dust spot efficiency can be installed in FCUs. Ensure that installed filters are of a proper size and installed in a manner to eliminate particle bypass of the filter. Note that increased filtration can reduce airflow produced by the FCUs by increased resistance. Prior to any increase of filtration, each unit should be evaluated by a ventilation engineer as to whether they can maintain function with more efficient filters.
 7. Render airtight all open pipes and spaces around pipes in FCU cabinets.

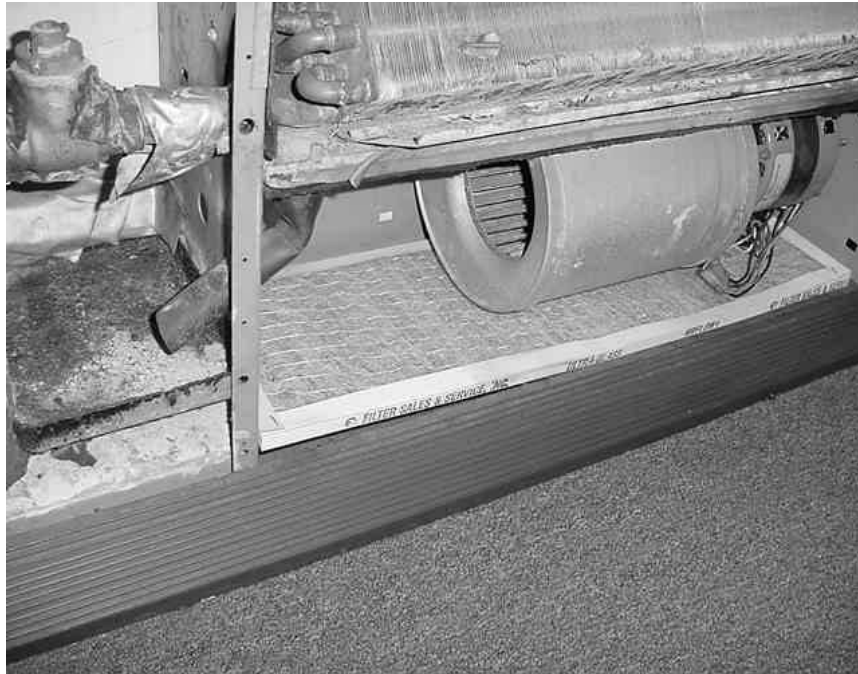
Picture 13

The interiors of several FCUs were examined. As FCU motors operate, the fan chamber depressurizes, drawing air from the room into the cabinet through the return vent. If holes exist in the fan chamber, air may also be drawn from the chambers containing controls and utility pipes. If holes into the exterior wall cavity exist in the controls and utility pipe chambers, then air debris can be drawn into the fans and distributed into rooms. Each FCU examined had holes in the fan chamber walls as well

as openings into the exterior wall cavity (see Picture 13) from the controls and utility pipe chambers. In this condition, air and pollutants can be drawn into fans and distributed into offices.

Holes In the Fan Chamber Walls As Well As Opening into the Exterior Wall Cavity
